## Is Your Pipeline Corroding?

### Abstract

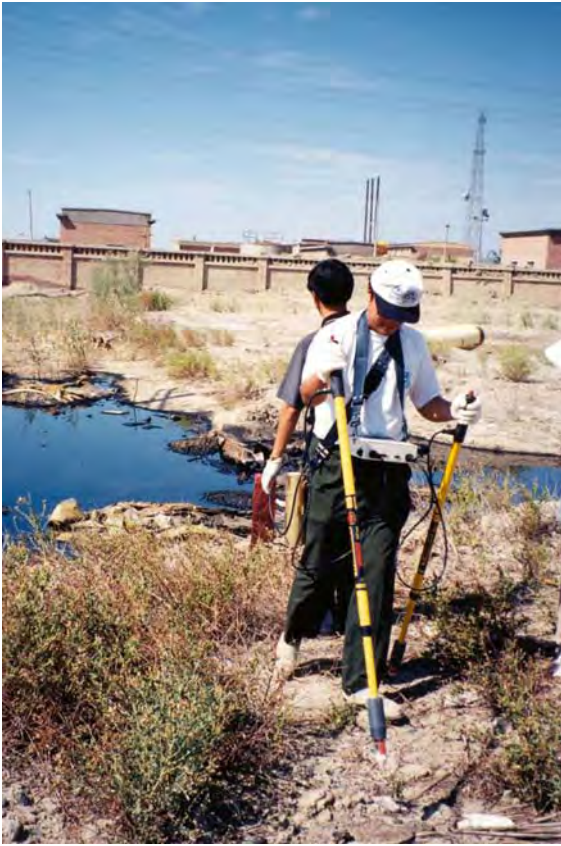
Figure 1 CIPS Survey near Oil Spill

Figure 1 shows a close interval potential survey being undertaken around a pool of spilt crude oil. Had the pipeline operators been vigilant in applying the principles of RP0502-2002 (3) and SP0207-2007 (5), they would have realized that the pipeline was corroding and could have taken action to improve the level of cathodic protection and thus prevented the leak.

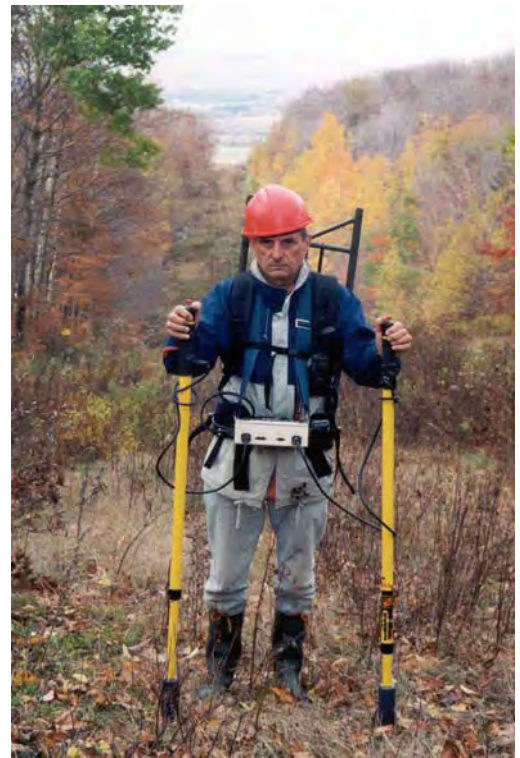
Figure 2 CIPS Surveyor in the Mountains

A significant amount of underground or underwater pipelines in the world do not lend themselves to In Line Inspection ILI (Smart Pig) due to their size, geometry or other factors. NACE Recommended Practice RP0502-2002 (3) requires that a close interval survey (Figure 2) be conducted on all underground/underwater pipelines. On pipelines where internal inspection cannot be used, an above ground coating integrity survey should also be performed. There are several methods of undertaking an above ground coating integrity survey. The most popular method is a direct current voltage gradient survey (DCVG), Figure 3. NACE International Standard Practice SP0207-2007 (5) specifies the method of undertaking close interval and DCVG surveys.

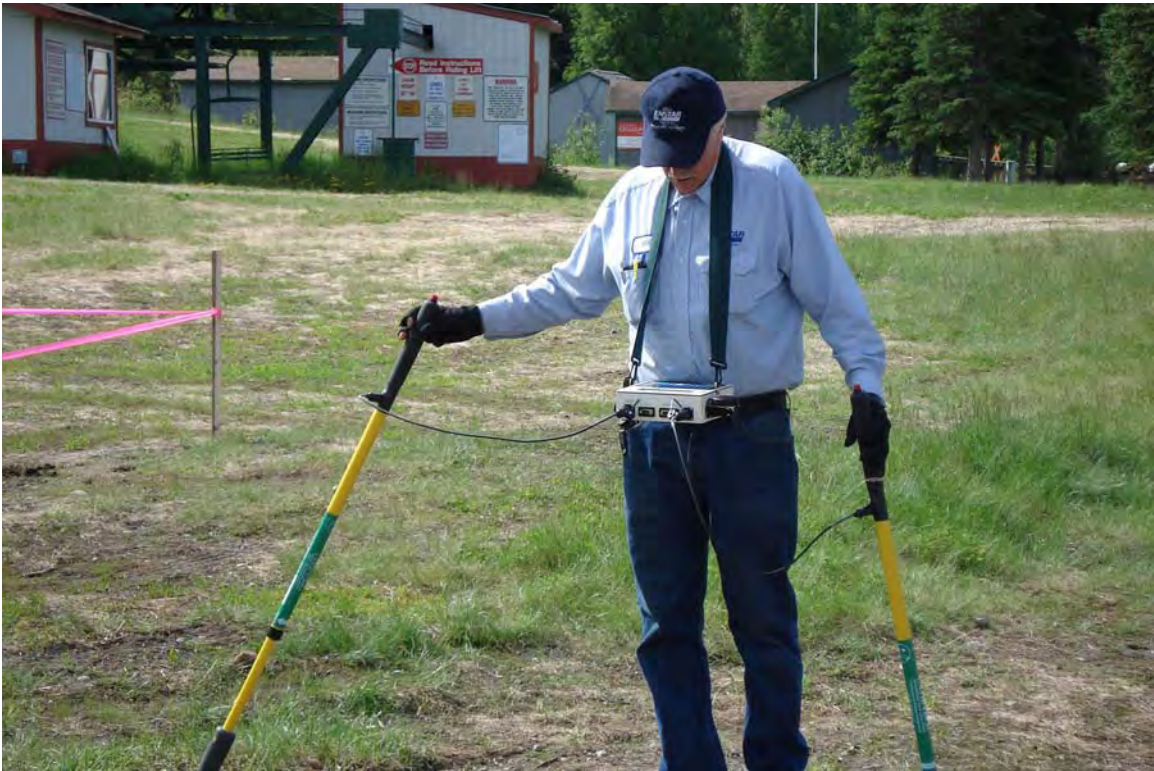
Figure 3 DCVG Surveyor

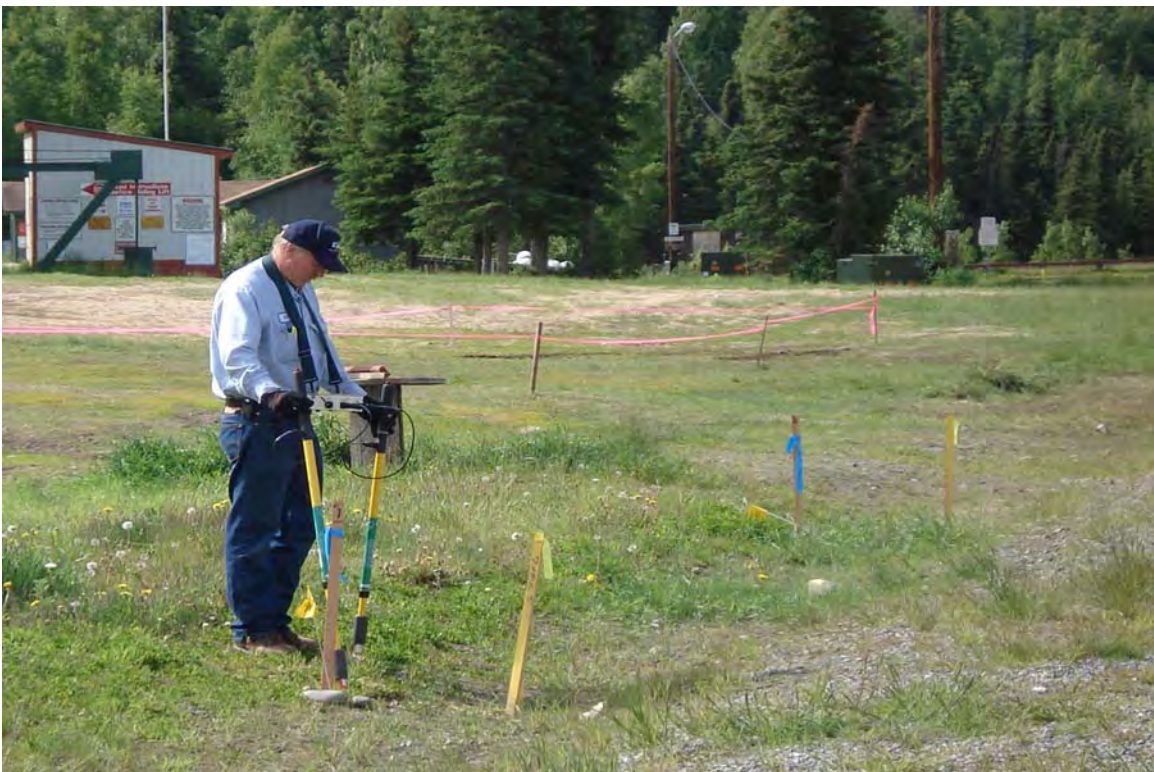
Figure 4 DCVG Surveyor with Stake-Outs of Defects

The direct current voltage gradient surveys have traditionally been undertaken with an analogue instrument without a connection to the pipeline whereby the operator stakes out the location of coating defects (Figure 4) and estimates the size or severity of the defect by comparing the voltage gradient associated with the defect to the average potential shift of the pipeline as measured at the closest test stations. Spatial disparity errors occur when the results of two distinctly different surveys are merged or combined, presenting a problem for the corrosion engineer in interpreting the results.

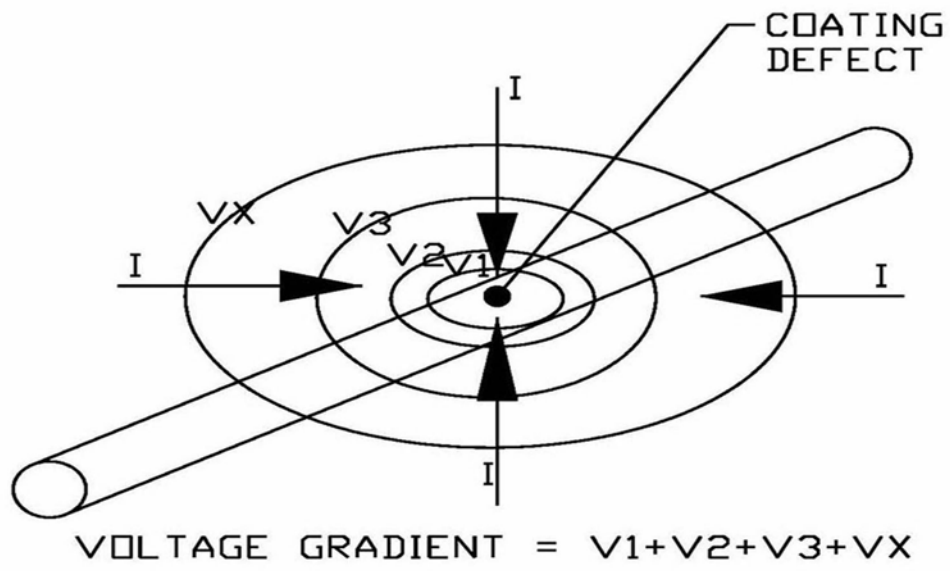
Figure 5 Voltage Gradients around a Coating Defect

There is a lot of misunderstanding about DCVG surveys, although the principle is quite simple and has been used for many years in various forms. On a coated pipeline that is cathodically protected, current flows from the anode of the cathodic protection system to holidays or defects in the coating. This current flow to the defects can be measured as a voltage between two electrodes on the surface of the ground. The voltage developed between two points on the surface of the ground obeys Ohms law,  $V = IR$  where  $V$  is the voltage gradient and  $I$  is the current flow to the coating defect or holiday and  $R$  is the resistance of the soil between the two electrodes (Figure 5). When two electrodes are placed on the surface of the soil, a voltage can develop between the electrodes due to soil chemistry, moisture content, contact resistance, etc. In order to easily sort out the difference between voltages generated by electrode contact with the earth and voltages due to current flow to a coating holiday or defect, the DCVG surveyor pulses the rectifier output by installing a current interrupter that cyclically

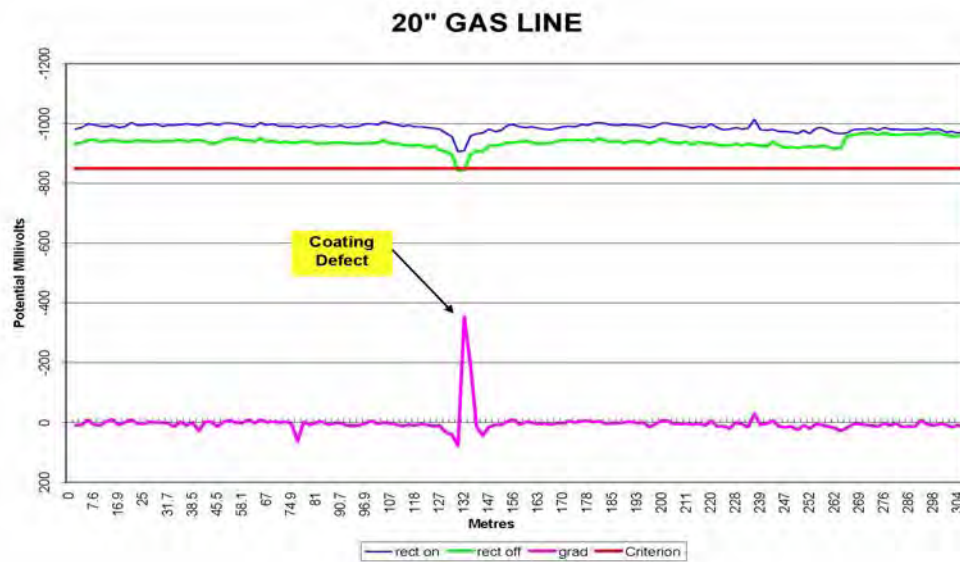
Figure 6 Coating Defect

interrupts the rectifier. Since the DCVG surveyor is limited on how far apart he can place the electrodes on the soil and since the voltage in the soil to a small holiday may only be a few millivolts, the DCVG surveyor often increases the output of the rectifier to increase the voltage gradient in the soil to make it easier to recognize the current flow to the defect (Figure 6).

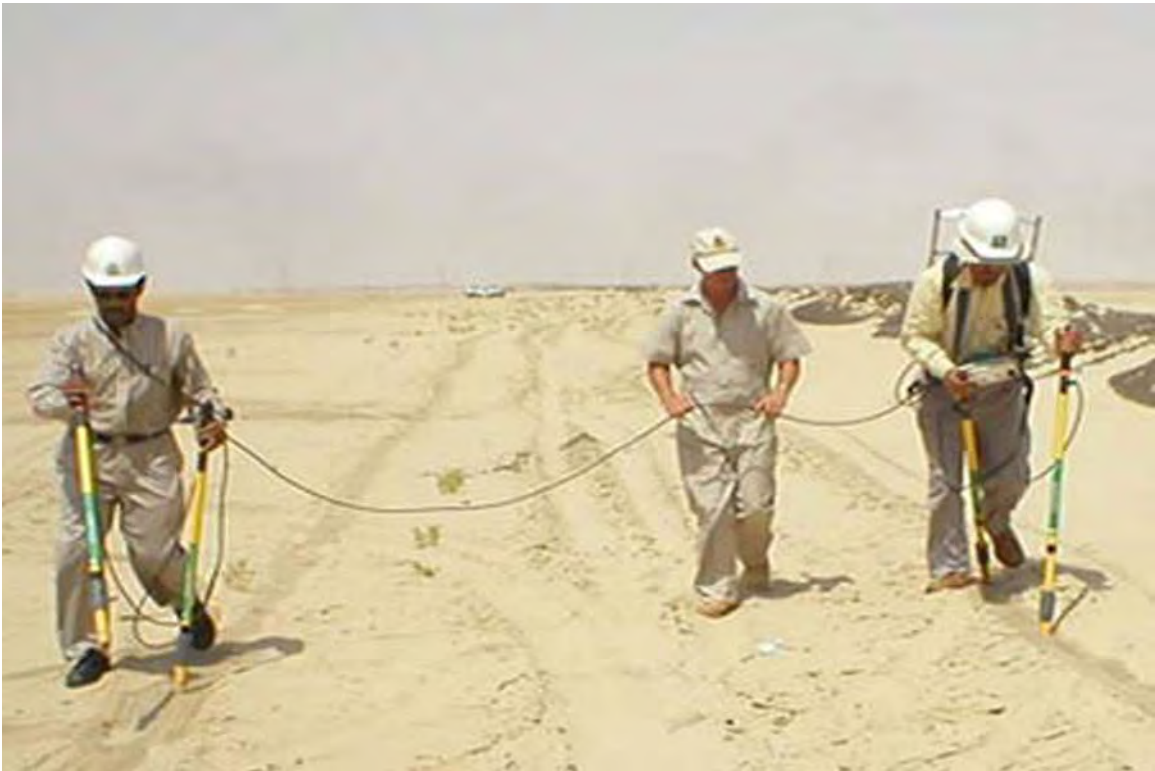
Figure 7 Combined CIPS + DCVG Survey Crew

When undertaking a combined CIPS and DCVG survey, the surveyor must walk on top of the pipeline. Under certain conditions the second or gradient surveyor can walk beside the surveyor about 5 to 7 meters away from the pipeline (Figure 7).

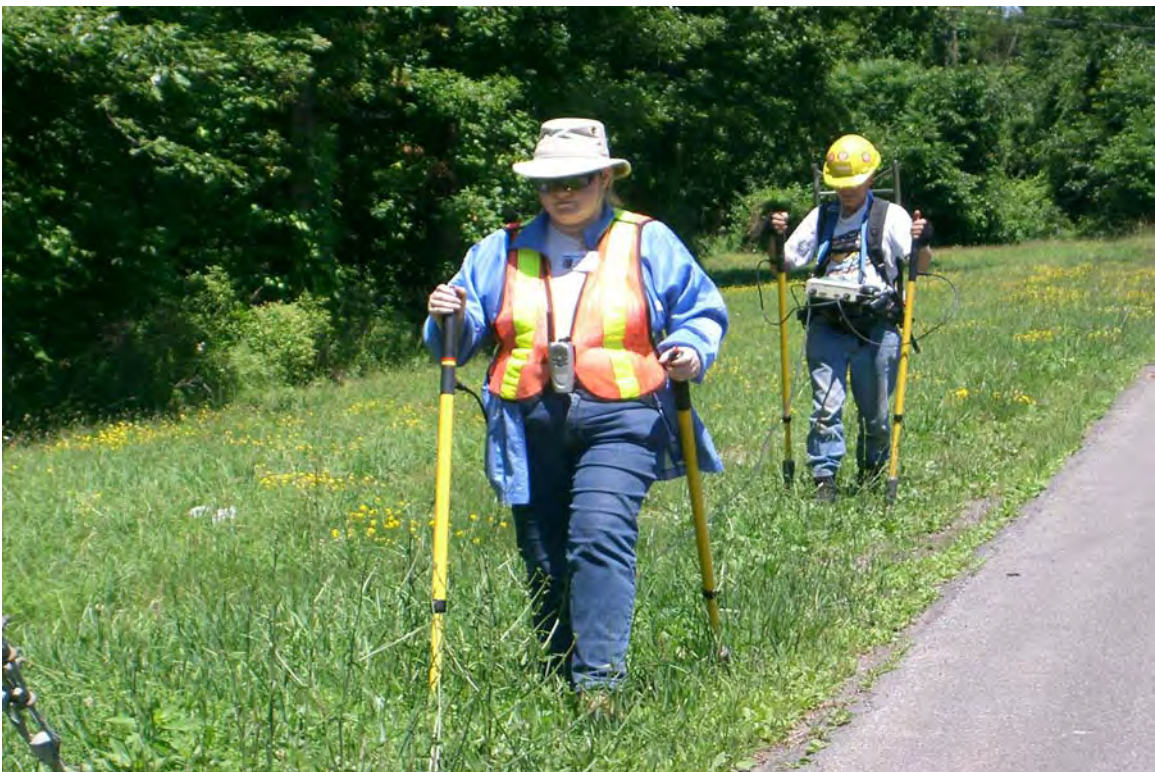
Figure 8 Two Surveyors Performing CIPS + DCVG Survey

In most instances the second surveyor cannot walk adjacent to the surveyor but must walk ahead of or behind the surveyor (Figure 8), to reduce the incidence of the umbilical cable getting caught on sticks and brush. When the gradient surveyor walks either ahead of or behind the surveyor, a distinct pattern representing the coating holiday or defect is produced in the form of a sine wave - see Figure 11.

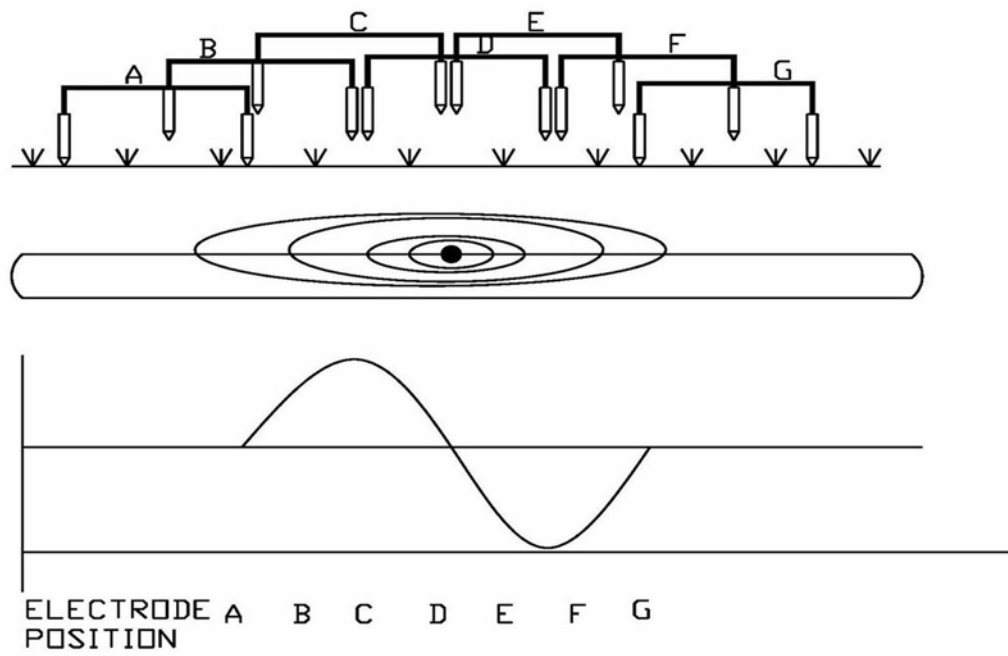
Figure 9 Sine Wave Signature of Coating Defect

The sine wave is the result of the electrodes measuring the voltage gradient while entering and leaving the voltage gradient field around a coating holiday or defect. As the surveyor approaches a coating defect, the voltage gradient electrode becomes more positive than the trailing surveyors gradient electrode. As the surveyors move along the pipeline, the lead surveyor's gradient electrode becomes more and more positive in relation to the trailing surveyor's electrode until the epicenter of the defect is reached. At that location, the maximum voltage gradient is recorded between the lead surveyor's electrode and the trailing surveyor's electrode. As the defect epicenter is passed, the voltage gradient measured between the lead surveyor's and the trailing surveyor's electrodes decreases. As the trailing surveyor approaches the defect, the voltage is reversed in that the trailing surveyor's electrode becomes more positive than the lead surveyor's until the coating defect epicenter is reached. The voltage gradient decreases as the trailing surveyor moves away from the coating defect epicenter - see Figure 9.

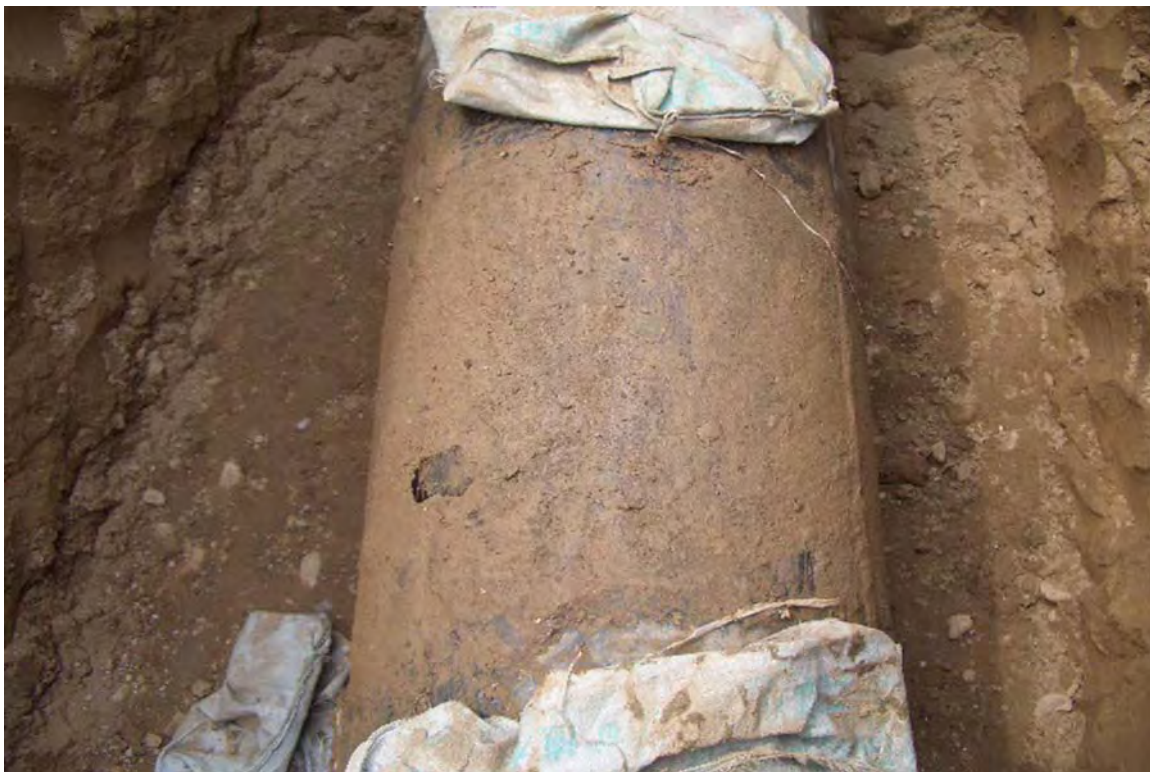
Figure 10 Uncoated Pipeline Joint

Figure 10 shows an uncoated pipe joint located by a combined CIPS and DCVG survey. Figure 11 shows the rectifier on and off pipe-to-soil potentials along with the DC voltage gradients recorded at the coating defect. The uncoated pipe joint is located at the center of the sinusoidal waveform shown on the graph (Figure 11). The uncoated pipeline joint was located in an urban area subject to dynamic stray current from an electrified railway system. No evidence of corrosion was found and the exposed steel had a thick coating of calcareous material indicating the exposed pipe was cathodically protected.

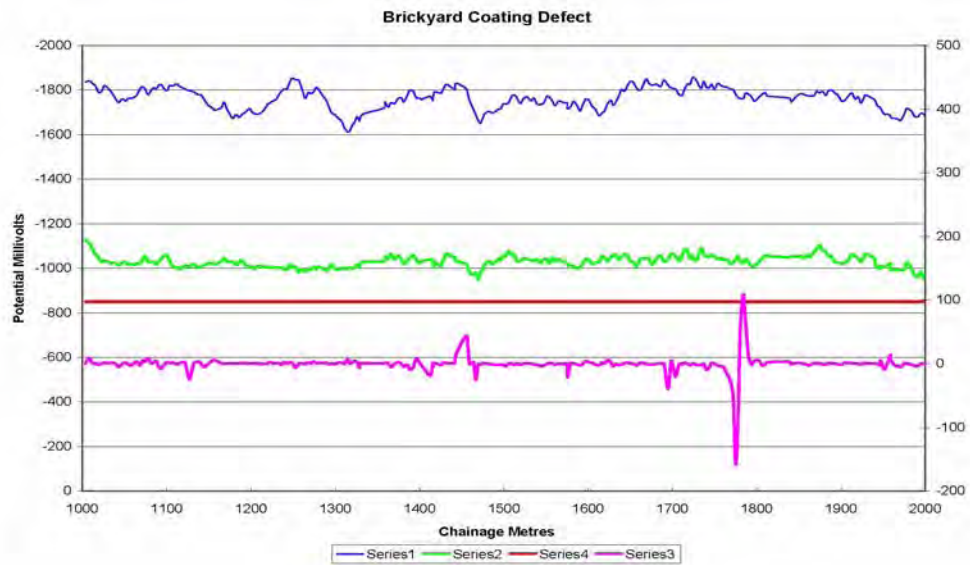
Figure 11 Graph of Pipe-to-soil Potentials with DC Voltage Gradient at Uncoated Pipeline Joint Shown in Figure 10

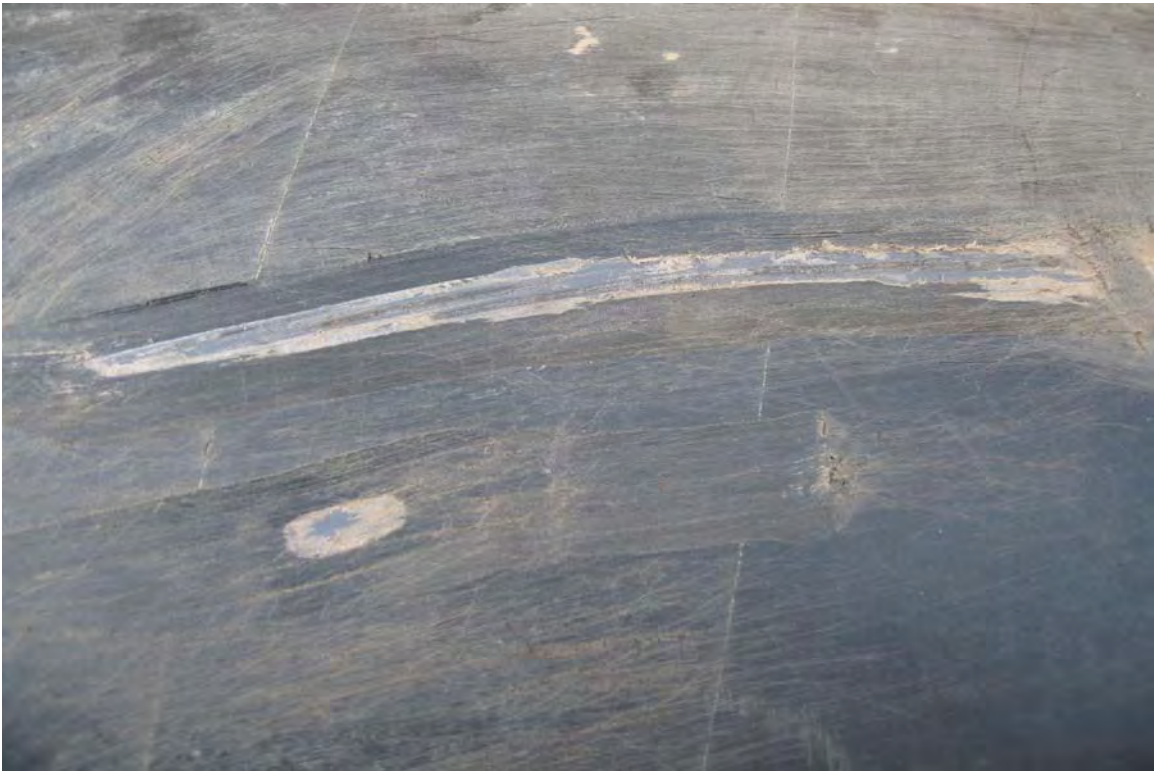
Figure 12 Coating Damage on a 20" Gas line

Figure 12 shows damage to the coating on a 20" gas line, probably caused by mechanical equipment. The coating defect was located during a combined CIPS and DCVG survey. Although there is little effect on the pipe-to-soil potential, the DC voltage gradient indicated that there was a coating defect. Figure 13 shows the results of the combined CIPS and DCVG survey which located the coating defect shown in Figure 12. There was no evidence of telluric or stray current activity at this location. The instant off pipe-to-soil potential averages -1100 millivolts with over 1500 millivolts of IR drop. After excavating for training purposes, the pipeline appeared clean with no evidence of corrosion. The instant off potential at this location was approximately -1000 millivolts.

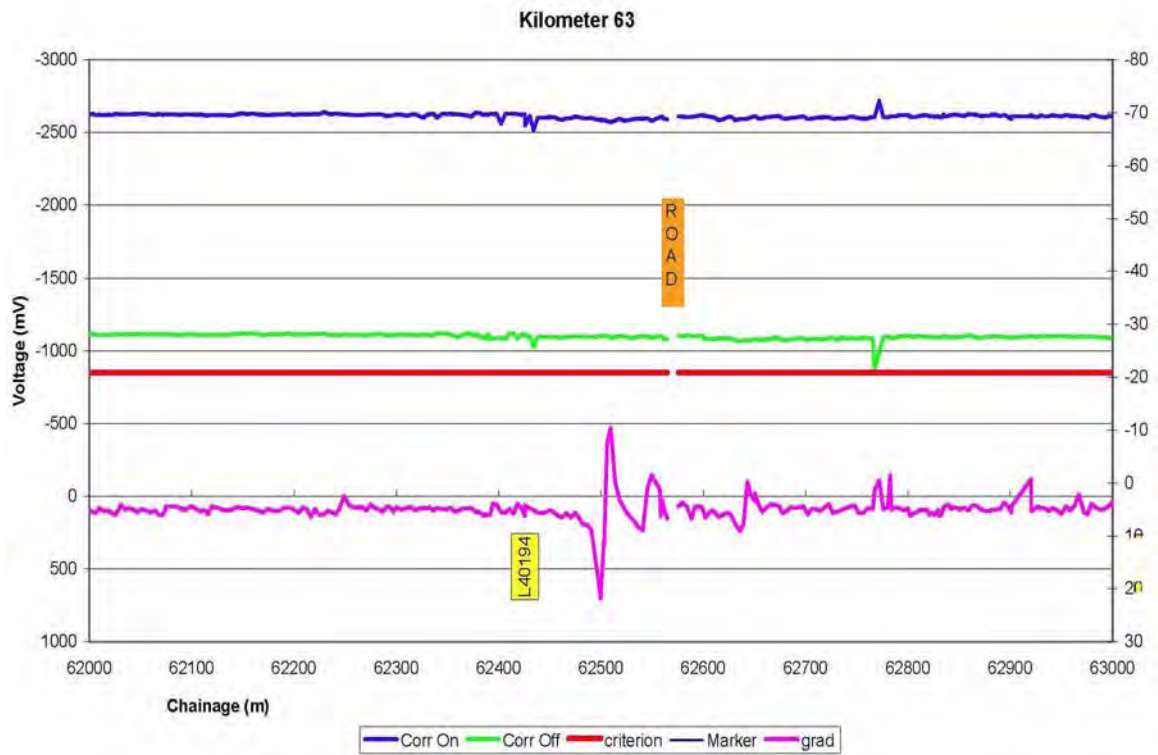
Figure 13 Voltage Gradient Sine Wave at Coating Defect in Figure 12

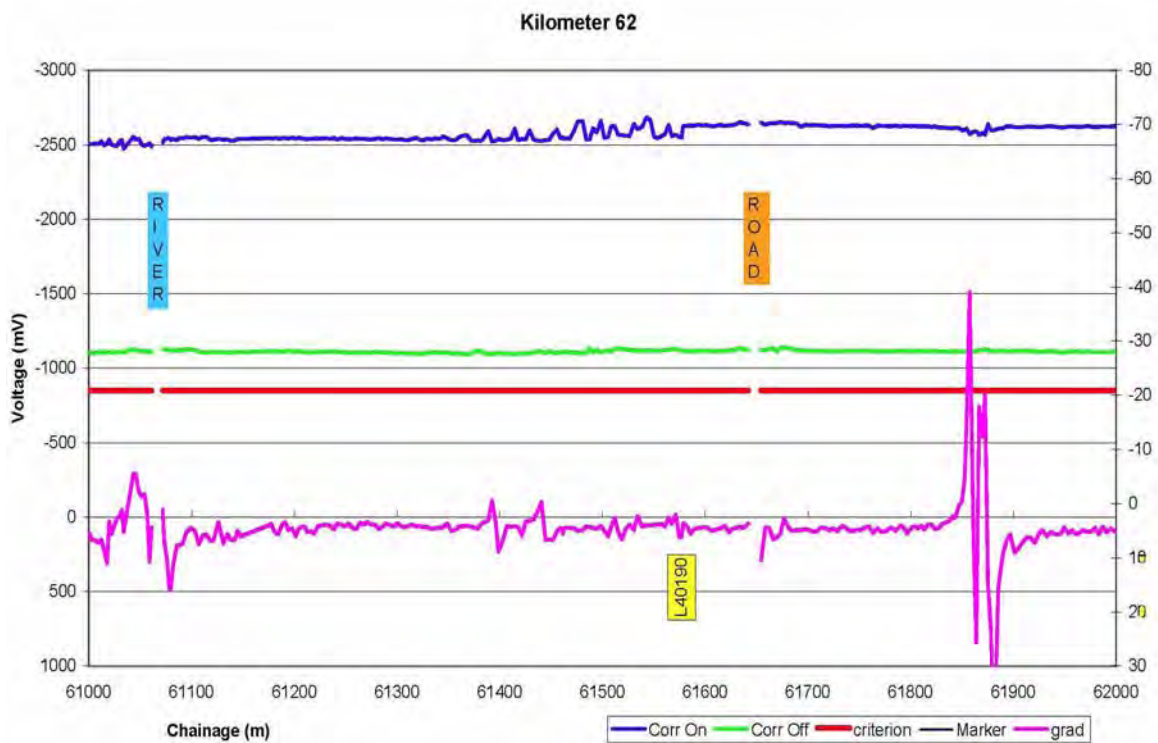
Figure 14 Voltage Gradients at Multiple Coating Defects Shown in Figure 15

Figure 15 shows the coating defects located by the combined CIPS and DCVG survey shown in Figure 14, probably caused by a backhoe. It is evident that the pipeline was cathodically protected at the defect with no corrosion evident. This defect was excavated as part of a training exercise for pipeline personnel although the pipe-to-soil potentials indicated that the pipeline exhibited adequate levels of cathodic protection.

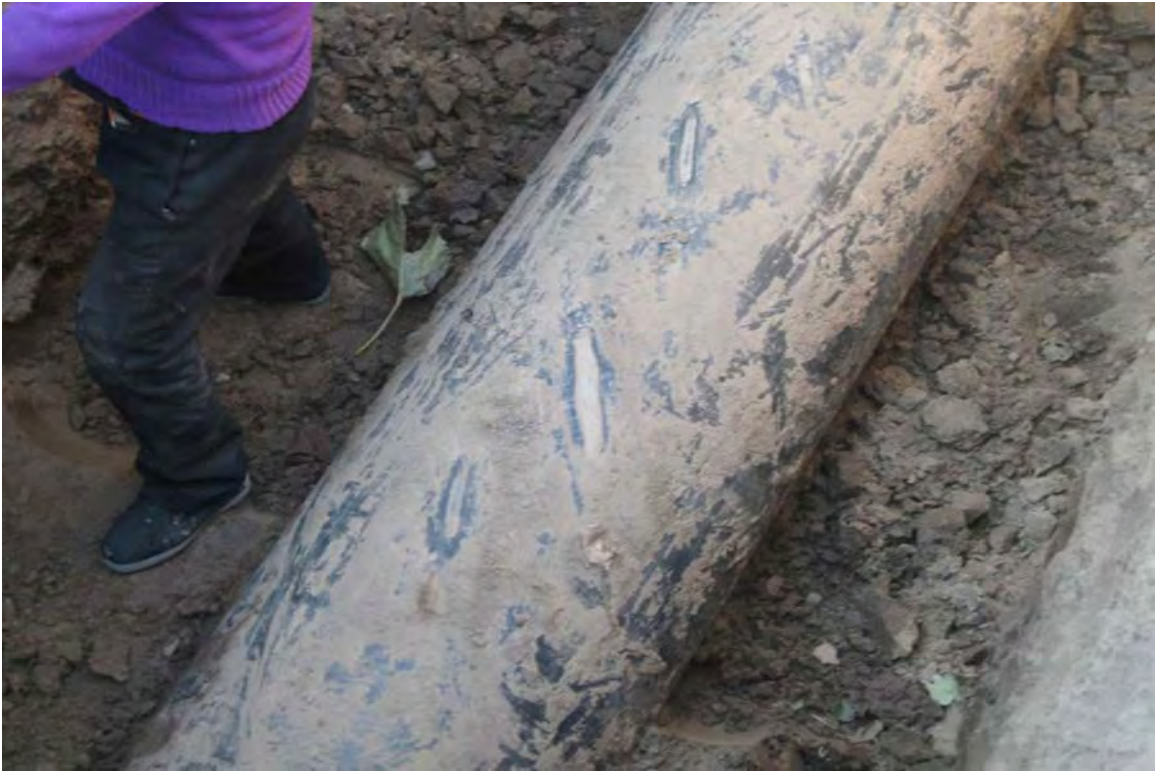
Figure15 Showing Backhoe Damage to Pipeline Coating

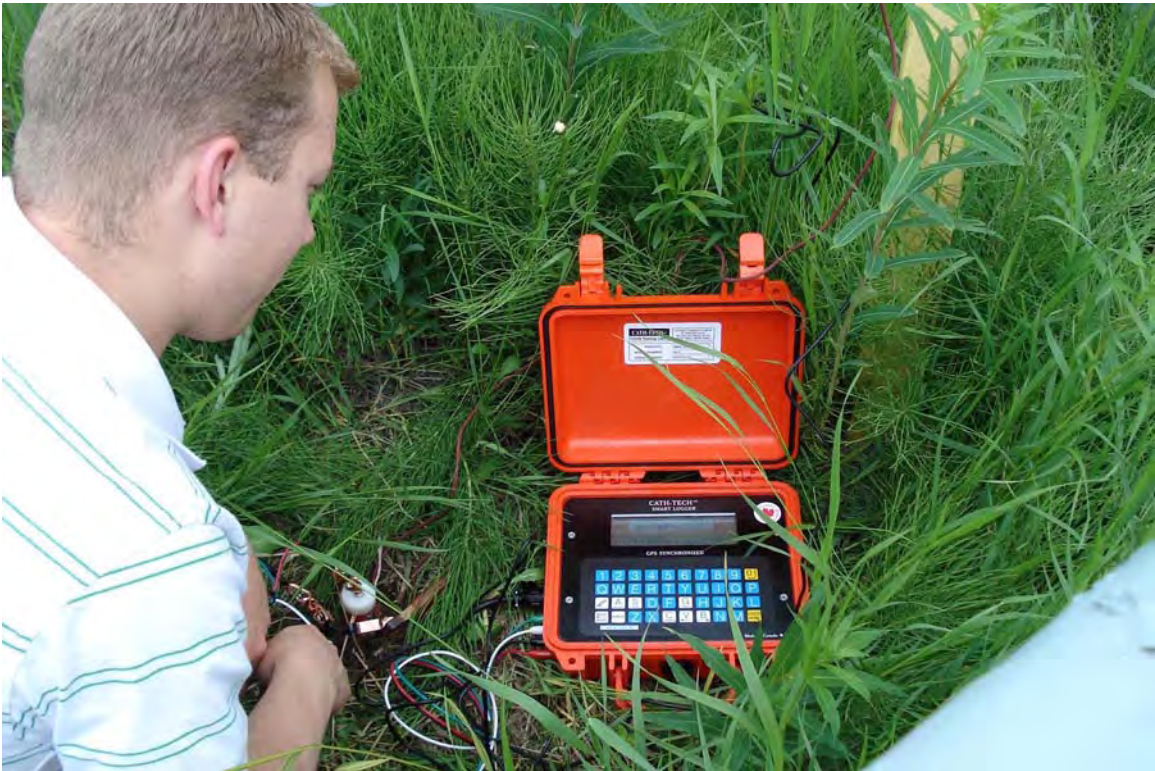
Figure16 Data logger With GPS Timing in Operation

Figure 16 shows a stationary data-logger with GPS timing installed at a test station. Figure 17 shows a graph of the data recorded by a stationery logger with GPS timing. Fluctuation of the pipe-to-soil potential in excess of 400 millivolts is evident; this potential shift is due to dynamic stray currents from an electrified railway. The data recorded by the stationery data logger with GPS timing will be used to correct the CIPS data shown in Figure 18 recorded during a combined CIPS and DCVG survey. This correction of the CIPS data meets the requirement of recommended in the NACE International Standard Practice SPO0207-207. Figure 19 shows the CIPS and DCVG data before applying correction from the stationary data logger.

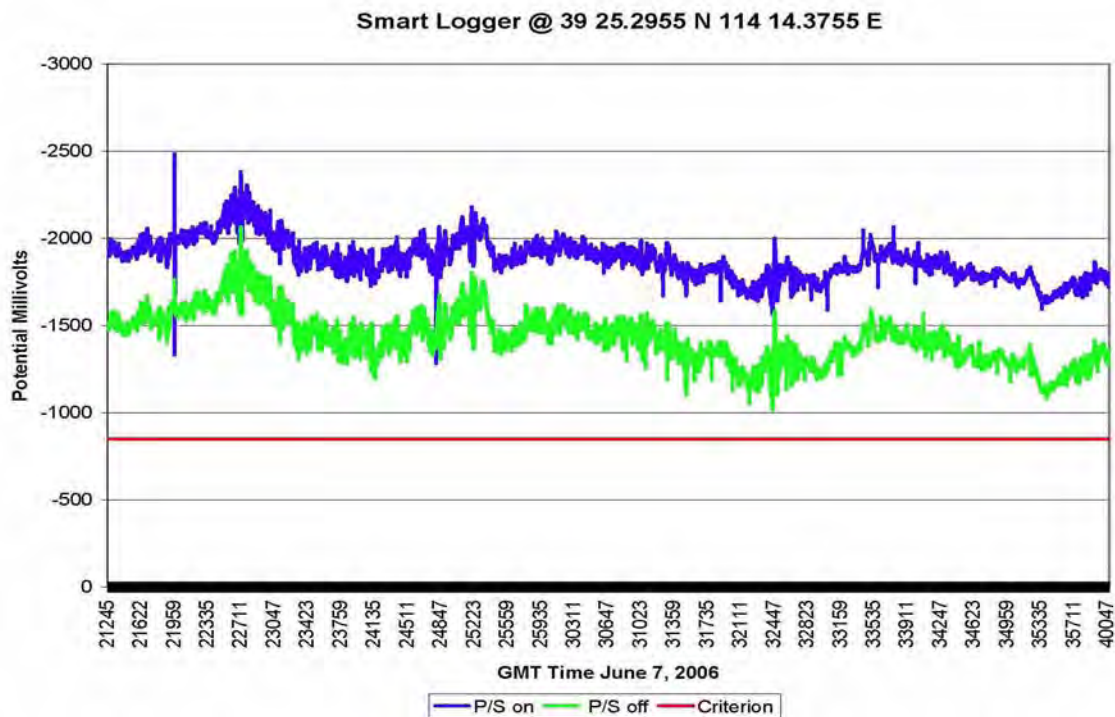
Figure 17 Data Recorded During Survey by Stationary Data Logger with GPS Timing

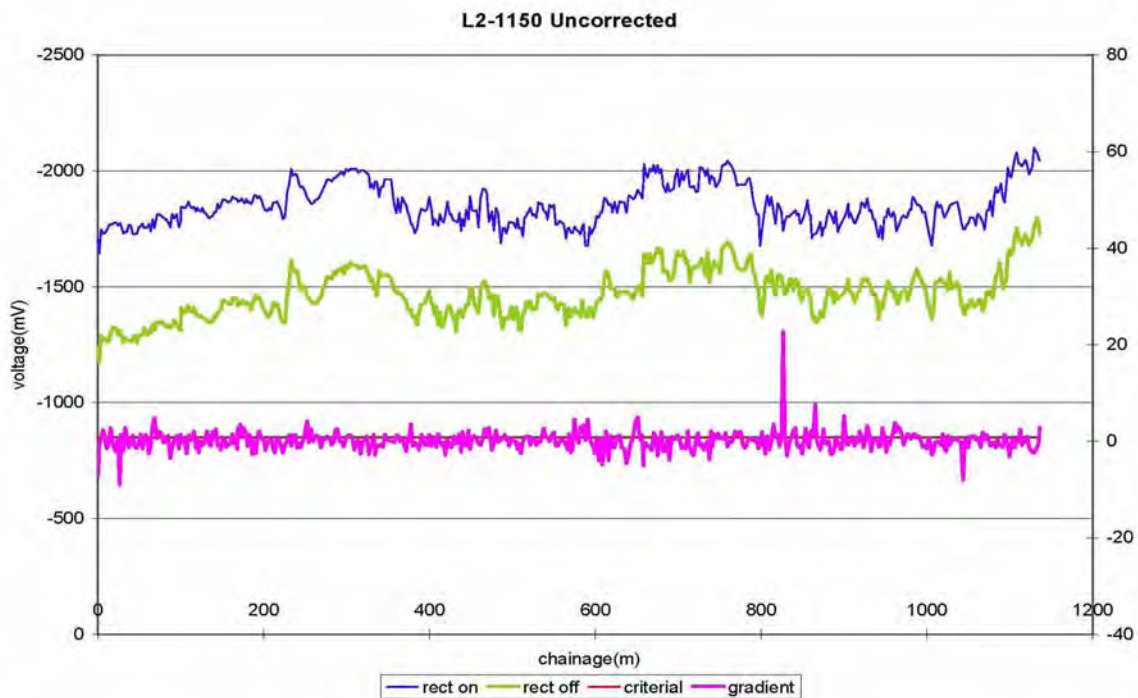
Figure18 Uncorrected CIPS Data Affected by Dynamic Stray Current

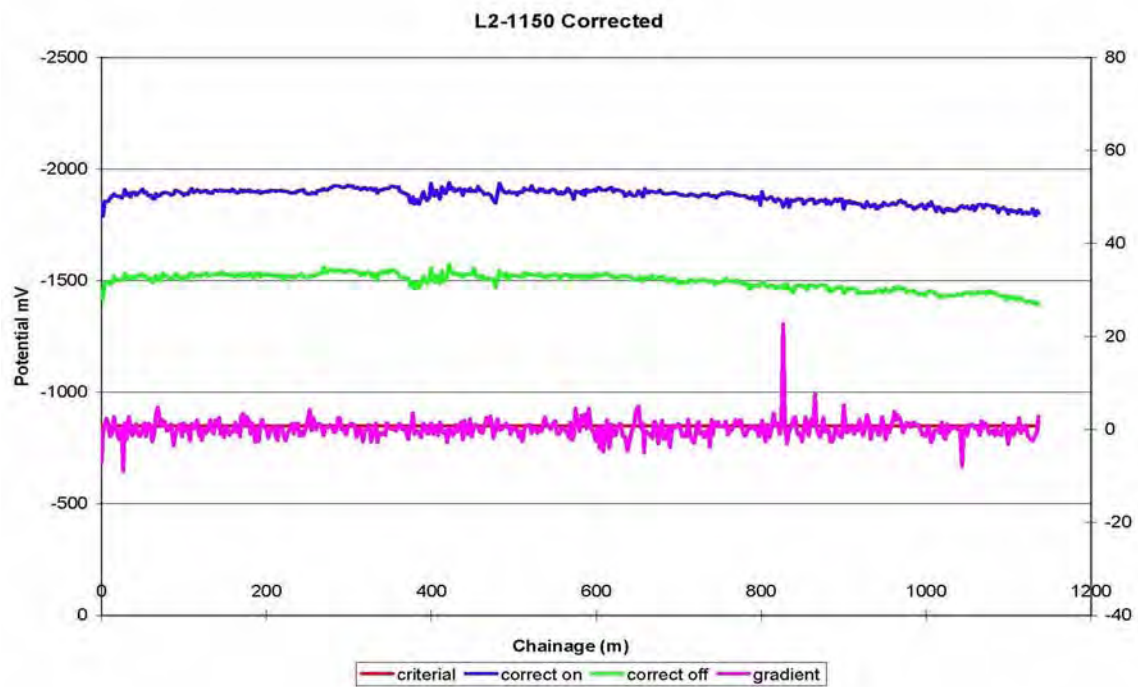
Figure 19 CIPS and DCVG Data from Figure 16 after Correction  
for Stray Current Using Data Shown in Figure 18

The DCVG data was not corrected as it is unaffected by the DC stray current at this location. Where stray or telluric current interference is occurring it can be easily corrected using the stationary logger data and a spread sheet program. No special software is required.
