Combined CIPS and DCVG Survey For More Accurate ECDA Data

J. Peter Nicholson
Managing Director
Cathodic Technology Limited
Bolton Ontario Canada

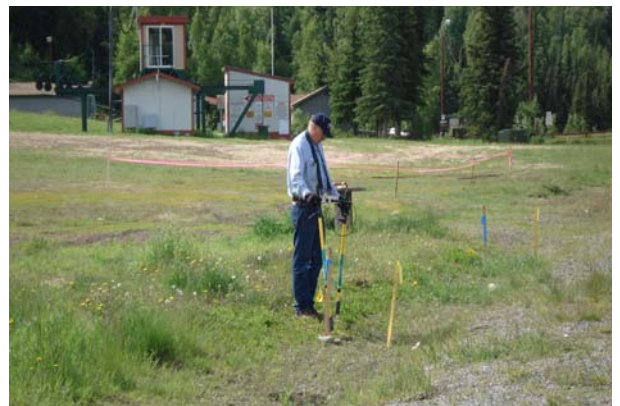
Photograph 2 Defect Stakeouts using Analogue DCVG Instrument

Because analogue DCVG instruments cannot measure or store chainage or GPS coordinates, coating defect locations must be staked (Photograph 2) and then the distance manually measured from a reference point. This contributes to errors and in time the loss of stakes indicating

the defect location due to traffic or other factors.

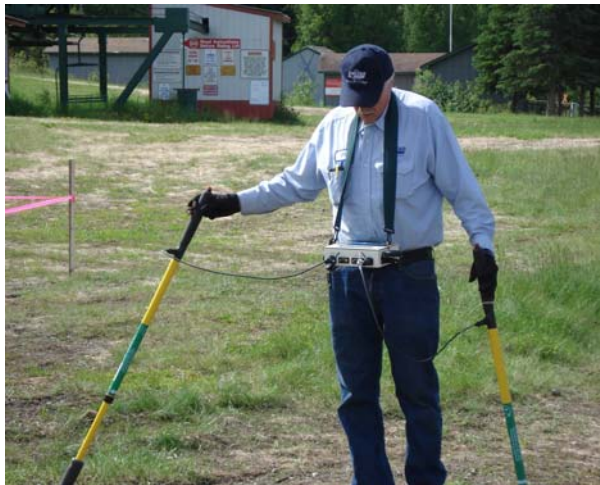
Photograph 3 DCVG Surveyor

The pulsed current causes the pointer on the meter to move rapidly and when operated correctly the movement of the pointer points in the direction of the coating defect. Since the voltage gradient around a defect dissipates quickly, small coating defects can be easily missed if the surveyor is not taking sufficient readings. The Cath-Tech™ Hexcorder™ Millennium

(Photograph 3) utilizes a bar graph to represent the movement of a meter needle. The bar graph points in the direction of the coating defect just as an analogue meter movement does.

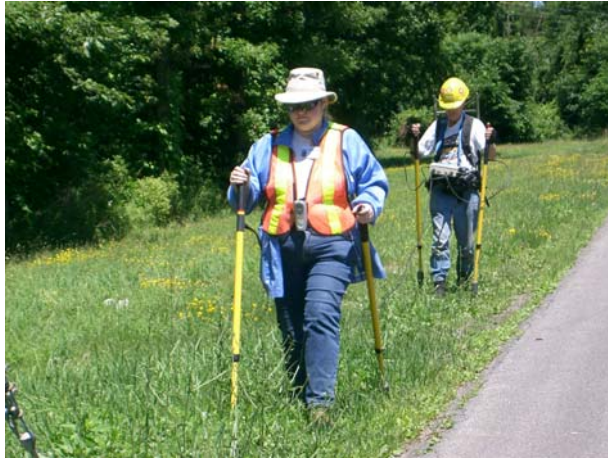
Photograph 4 Two Surveyors Performing a Combined CIPS and DCVG Survey

With analogue equipment it is necessary to take several readings in series adding each value to the previous to obtain the maximum voltage gradient associated with a defect. With the Hexcorder™ Millennium and two surveyors the maximum voltage gradient is automatically measured by spacing the two surveyors 5 to 7 meters apart (Photograph 4).

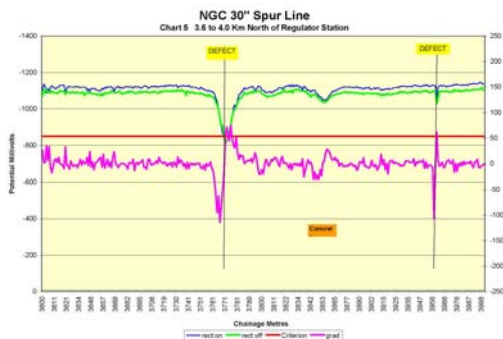
Graph # 1 Showing Results Of a Combined CIPS and DCVG Survey

There are two very evident coating defects shown on Graph 1. The defect at 3765 metres is significantly affecting the pipe-to-soil potential and corrosion may be occurring. The defect at 3960 metres is affecting the pipe-to-soil potential, but, the instant off potential is above -1000 mV, indicating the pipe is cathodically protected from corrosion.

When the results of a combined CIPS and DCVG survey where both surveyors are over the pipe are graphed even small coating defects are readily apparent due to the sinusoidal waveform produced by the voltage gradients associated with a coating defect.

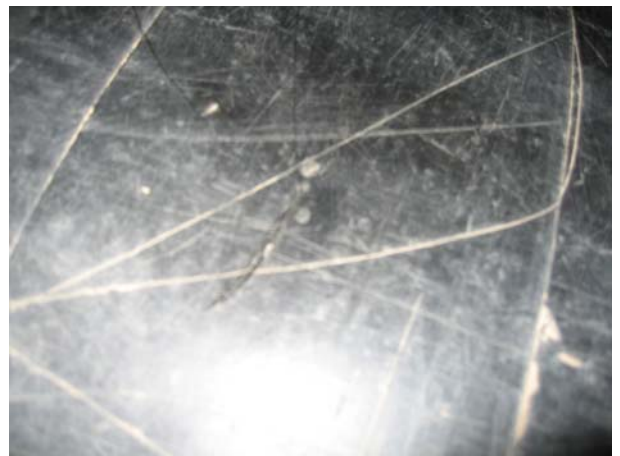
Photograph 5 Small Defect Detected by Combined CIPS and DCVG Survey

Even with low cathodic protection current flows that are experienced on three layer poly coatings, coating defects can be easily found using the two-surveyor technique. Photograph 5 shows a small defect detected by the two-surveyor

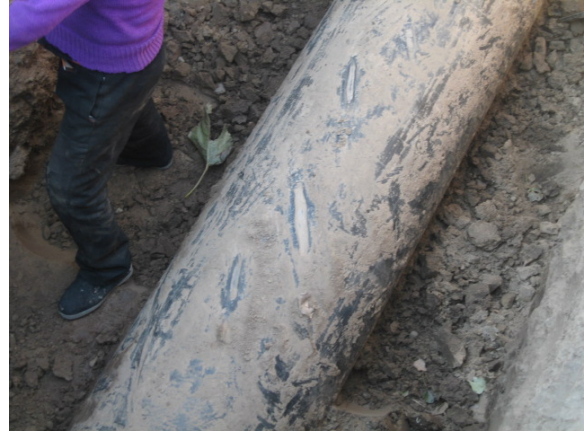
Photograph 6 Multiple Defects

The sinusoidal waveform becomes distorted where the defect consists of several defects close together or is of odd shape and size. Photograph 6 shows several defects on a pipeline probably caused by a backhoe bucket.

There was no evidence of corrosion at these defects shown in photograph 6 and Graph 3, the pipe-to-soil potential was in excess of -1100 millivolts with reference to copper copper sulphate, indicating adequate level of cathodic protection. The exposed steel is coated with a calcareous deposit indicating cathodic protection current flow to the defects.
